Engineering Geology for a Habitable Earth

Field Trip #1

THE XIV CONGRESS OF THE INTERNATIONAL ASSOCIATION FOR ENGINEERING GEOLOGY AND THE ENVIRONMENT

Field Trip #1: Chengdu---Dujiangyan---Yingxiu---Chengdu

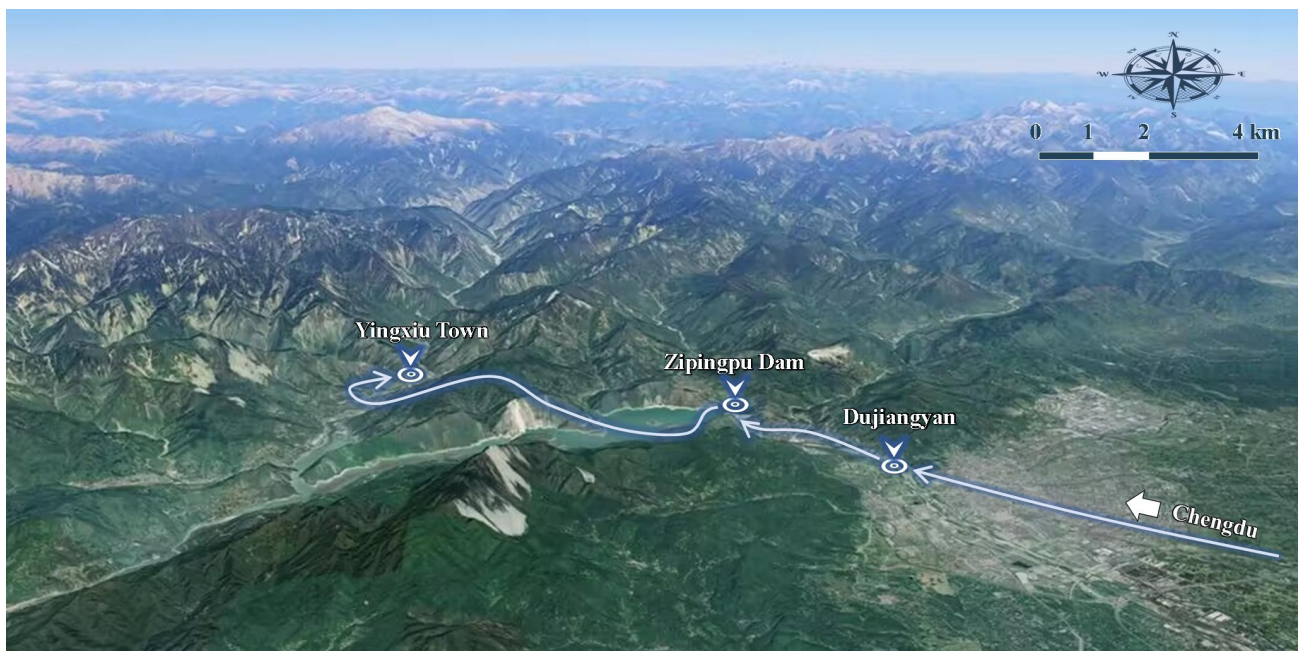
Fig. 1 The sketch map of the field trip itineraries

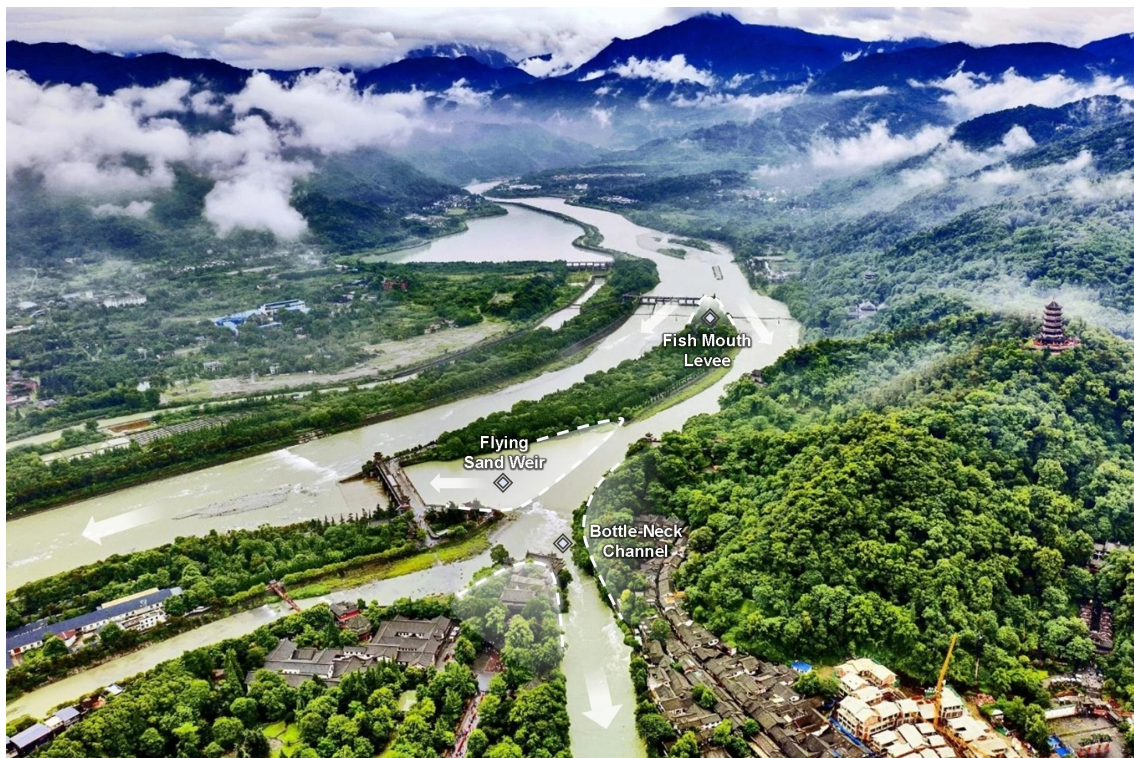
Fig. 2 The dujiangyan irrigation system

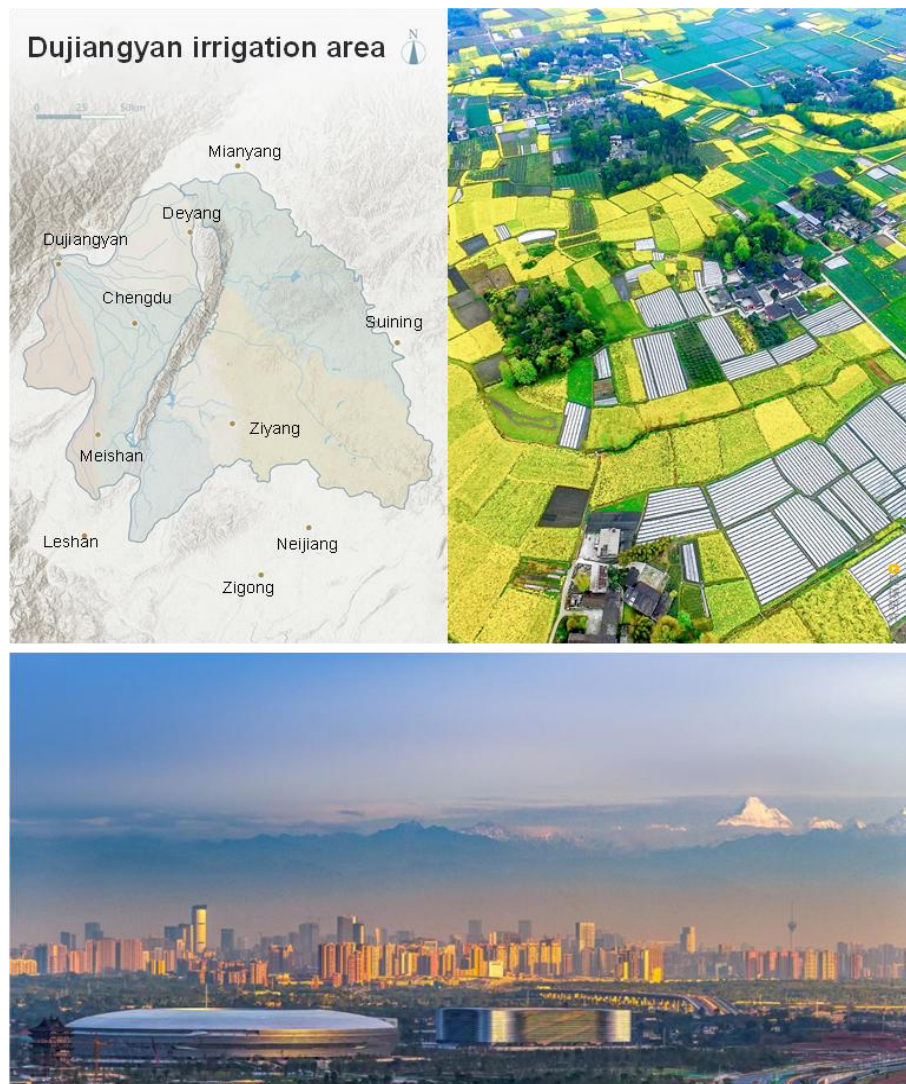
Fig. 8 The Dujiangyan irrigation system is still in use today to irrigate over 5,300 km² in the chengdu plain region and has produced comprehensive benefits in flood control, irrigation, water transport and general water consumption.

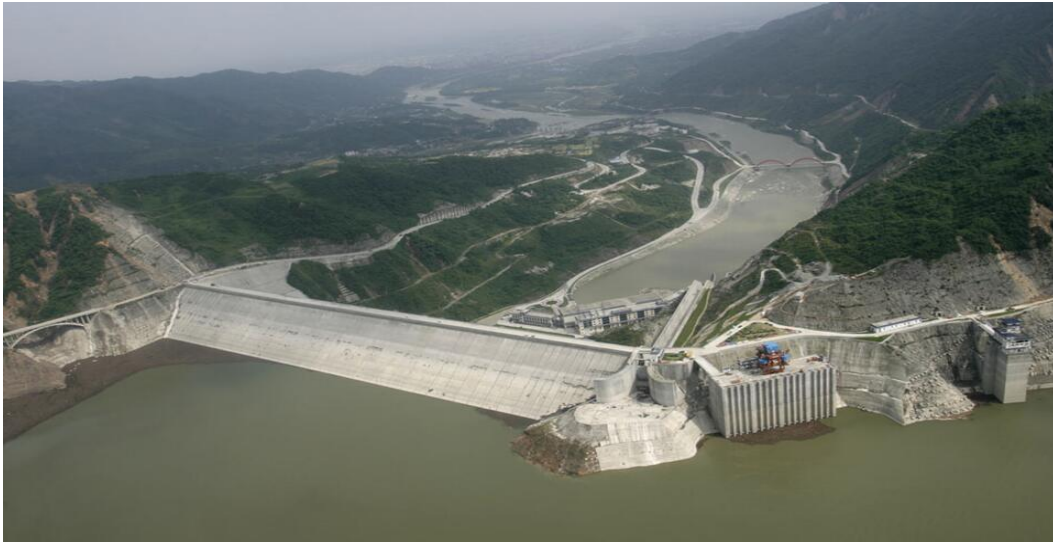
Fig. 9 Panorama of zipingpu water conservancy project.

The Zipingpu Water Conservancy Project is located on the MinJiang River, 9 and 60 km respectively upstream from the Dujiangyan City and Chengdu City-the capital city of Sichuan Province. The Minjiang River has a catchment area of 22662 km² above the dam, with a mean annual flow of 469 m³ /s and an annual runoff of 14.8×10⁹m³. The main functions of the project are irrigation and water supply, with comprehensive benefits in power generation, flood control, environment protection and tourism. The check and design flood levels, the normal and minimum pool levels are 883.10 and 871.20, 877.00 and 817.00 m, respectively. The total capacity of the reservoir is 1.112×10⁹m³.

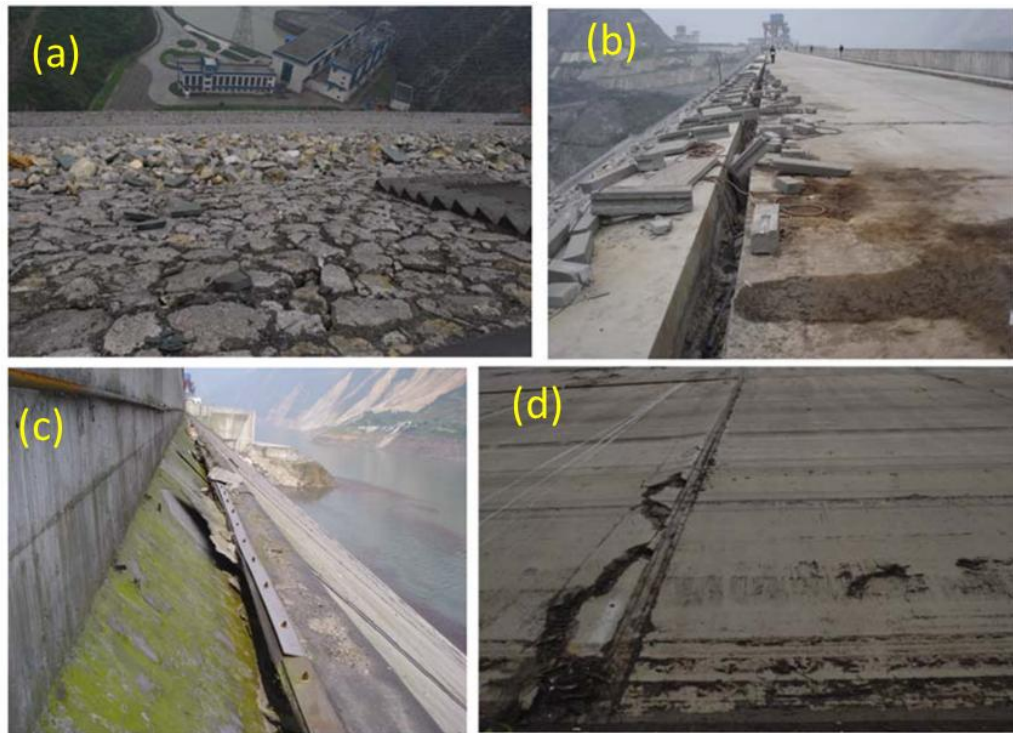
Fig. 11 Earthquake damages to the project structures. (a) loosen rock fills on the downstream side of the dam; (b) open and dislocation of the downstream border of the dam crest; (c) damages of the horizontal joints at the dam crest resulting from subsidence of the wave wall; (d) squeezing damages between the no. 23 and no. 24 slabs.

The damages of structures include cracking of the curb stones on the downstream side of the dam crest, tensile cracking and squeezing damage of the “L-shaped” up-stream wave wall, occurring respectively on its both sides and in its middle part.

The horizontal joints between the slab top and the wave wall were dislocated, resulting from the seismic subsidence. The rock fills were loosen and dislocated by the earthquake at the location of about one fifth of the dam height in the middle part of the dam. Some slabs were separated from the cushion layer and some construction joints were dislocated and some vertical joints were damaged by squeezing.

The No.5 and No.6 slabs on the left abutment were heaved up by squeezing and damaged severely, with a maximum dislocation of 350 mm. The joint between the No. 23 and No. 24 slabs was damaged by squeezing, extending from the dam crest to the elevation 791.00 m, 26.0 m below the dead storage level. The No.23 slab was damaged with a transverse width of 0.5-1.7 m, and a depth of 320 mm and a separation void of 50 mm, according to borehole inspection at the elevation of 843.00 m. The conformal mesh reinforcement between the slabs was separated from the protective layer of concrete. The stress steel bars in the middle of the slab were bended and the longitudinal squeezing damage is severer than that under normal condition.

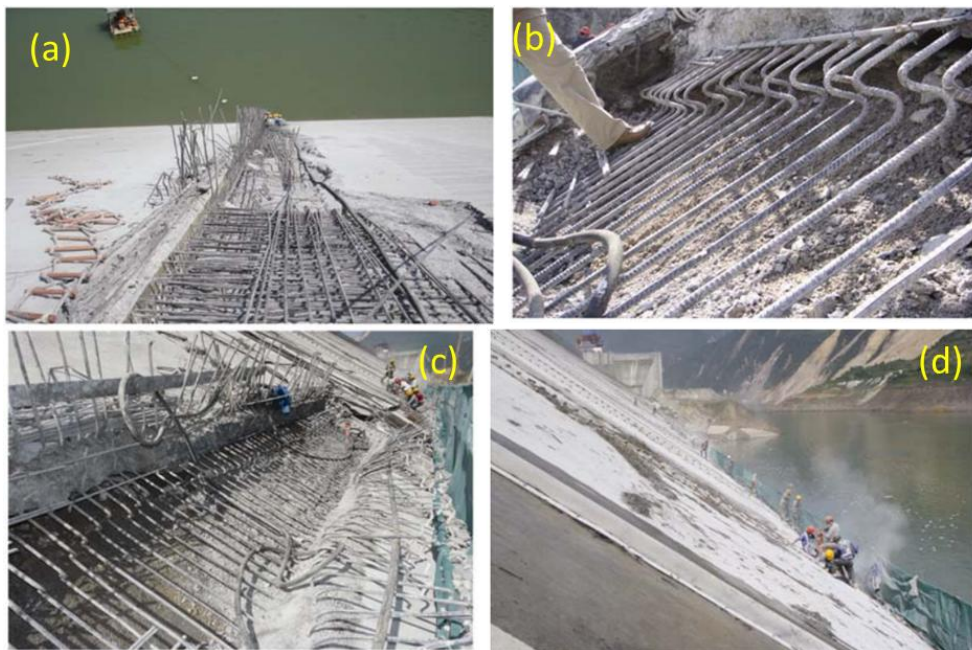
Fig. 12 Dislocation of the horizontal construction joints of the slabs. (a) excavation of the damaged longitudinal joint of the no. 23 slab (after removal of the broken concrete). (b) the exposed horizontal joints at el. 845 m after local removal of concrete. (c) repairing the dislocated horizontal joints of the no.8 slab (the stress bar bended in “s” shape). (d) repairing construction of the damaged slabs.

The construction joints of the second- and third-phase slabs were found dislocated obviously, with a dislocation of 15-170 mm for the slabs Nos. 5-12, 120-150 mm for the slabs Nos. 14-23, and 20-90 mm for the slabs Nos. 30-42, covering a total length of 340 m. After removal of the damaged concrete on the surface, it was found that the dislocation of the No. 8 slab caused “S” shaped bending of the stress steel bars in the middle part of the No. 8 slab, cracking and separation of the concrete below the stress steel bars of the third-phase slabs and breaking of the contact concrete. The horizontal dislocation of the No.10 slab reached 230 mm, resulting in shearing off of the copper seals between the slabs and exposure of the steel bars in the joints.

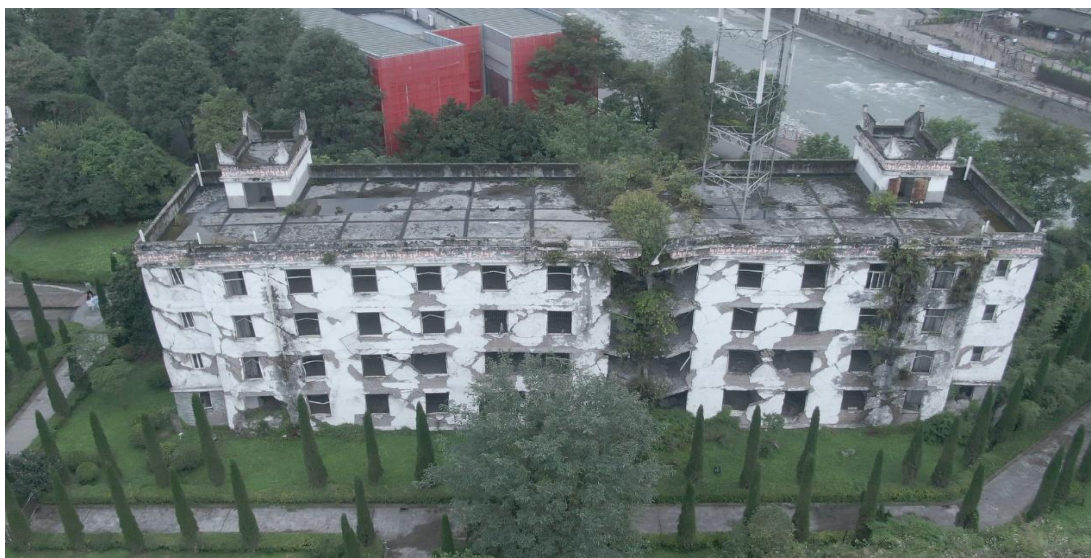
Fig. 17 The earthquake damage of xuankou middle school students' dormitory

Xuankou middle school students' dormitory had five stories (Fig.17), the underlying had serious damage and cross gable crack that extended to the vertical walls. In the upper stories, the wall under the windows and the wall between windows had cross damage too. The bottom of the vertical wall had serious damage but did not lose the carrying capacity of the structure. Figure 6 was teaching building. In addition, the foundation and the structure had been collapsed. The structure had collapsed with cross wall damage of each storey. The bottom storey had collapsed too, and the weak area in each storey collapsed and lack of storey yield(Fig.18).

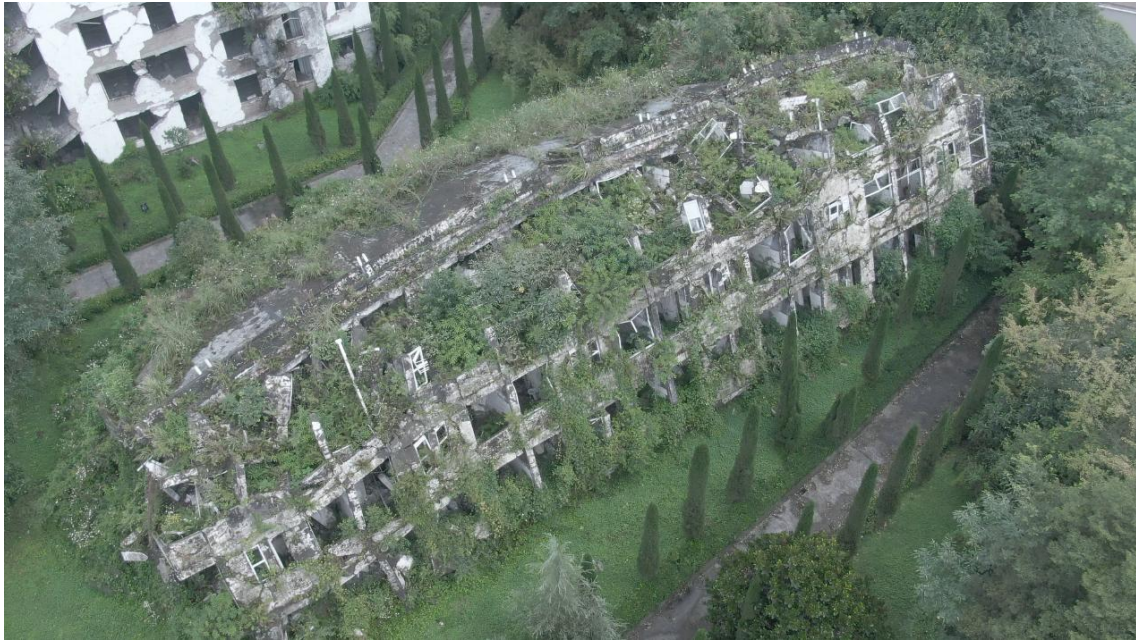
Fig. 18 The earthquake damage of xuankou middle school teaching building

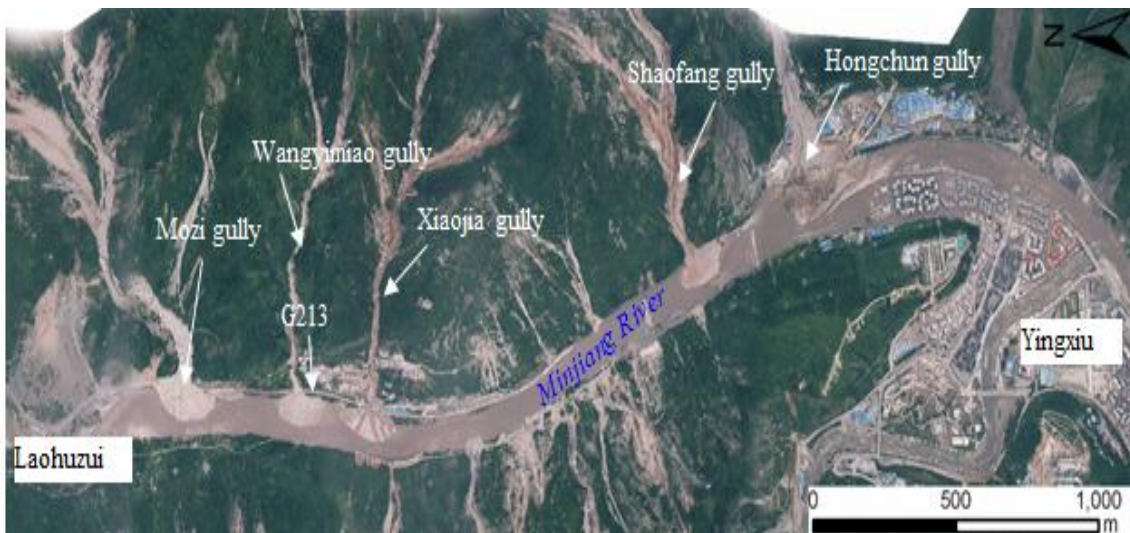
Fig.19 Aerial photo taken on august 15th, 2010 showing the debris flows induced by the august 13th-14th, 2010 heavy rainfall along the minjiang river (from yingxiu to laohuzui)

Since the Wenchuan earthquake in 2008, intense rainfall events have triggered a large number of debris flows (Fig.19), leaving more than 2,000 people dead or missing, and creating many problems during the restoration and reconstruction of the earthquake-affected areas (Wang et al., 2022). The Year 2010 was the most tragic disaster year for debris flows in the Wenchuan-earthquake-affected area (Fig.20). In succession, Yingxiu Town, which was located near the epicenter, suffered serious debris flow disaster and coupled flood event on 14 August 2010 (Xu et al., 2012; Chang et al., 2017).

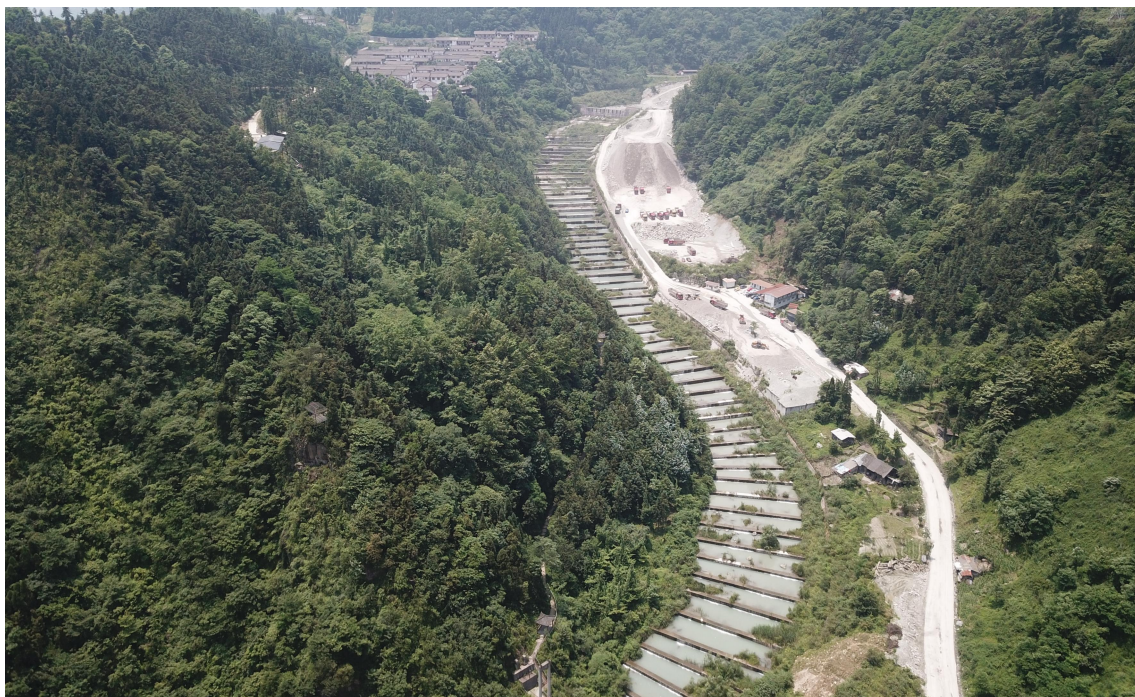
Fig. 22 Drainage channel of niujuan debris flow

The Niujuan Gully (Fig. 21, Fig. 22) was the epicenter of the "5.12" Wenchuan earthquake. The total length of the valley is 3 km, before the earthquake, a group of 33 villagers in Zhangjiaping Village lived here, the "5.12" Wenchuan earthquake began to tear the earth from here in Niujuan Gully, huge energy to smash the underground rocks, with a terrifying loud noise, millions of cubic meters of rock fragments ejected from the earth's crust, causing strange and terrible rock flows down the valley in a zigzag shape hitting the mountains on both sides of the valley, forming a huge source ejection, nearly 3 km long rock flow and 9 mountains hit such a unique source wonder. Before the Wenchuan earthquake in 2008, Niujuan Gully was a clear water gully. Unfavorable geological phenomena such as collapse and landslides in the basin were not obvious, and only a small volume of loose deposits was observed in the gully, with a total amount of approximately $93.97 \times 10^4 \text{ m}^3$. After the earthquake,

Niujuan Gully was transformed into a high-frequency debris-flow gully. Adverse geological disasters such as collapses and landslides in the study area affected by the earthquake subsequently strongly developed, with the material source amount caused by collapse and landslide having been estimated as approximately $695.22 \times 10^4 \text{ m}^3$, providing abundant loose solid materials for the occurrence of debris flows (Fan et al., 2019).

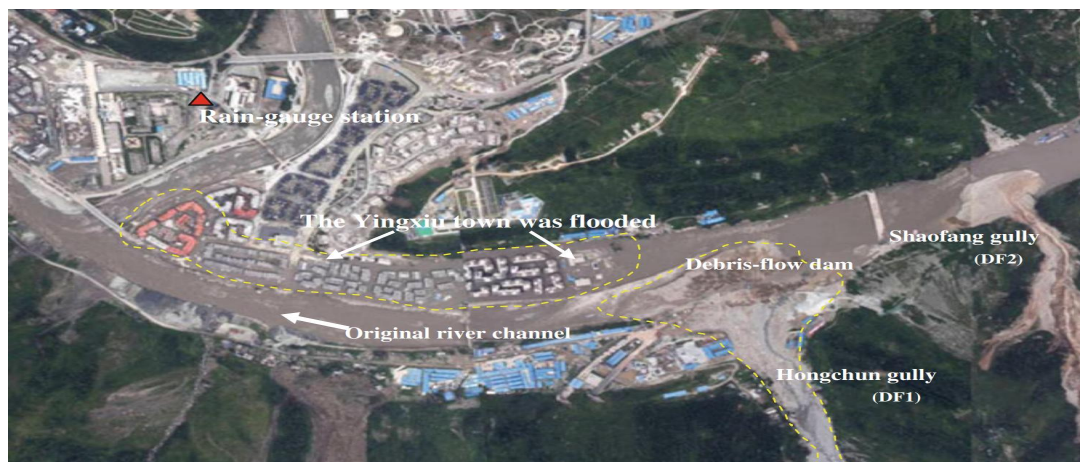
Fig. 23 Aerial photo showing the depositional fan of the hongchun debris flow (taken on aug 15th, 2010)

rocks, Sinian pyroclastic rock, Carboniferous limestone, and Triassic sandstone. On August 14, 2010, at 3:00 A.M., triggered by intense rainfall, numerous debris flows occurred near Yingxiu. These flows deposited mud, debris, and rocks onto the G213 national road and the Dujiangyan–Wenchuan highway (at that time under construction), and finally moved down into the Minjiang River (Fig.23). They produced debris dams that entirely or partially blocked the Minjiang River at tributary junctions resulting in severe flooding in Yingxiu. Hongchun Gully, one of these debris flows, produced a huge debris dam, which then changed the course of the Minjiang River and resulted in the flooding of the newly reconstructed Yingxiu Town. The peak discharge of the river increased from 570 m³/s to 1,400 m³/s on August 15th, shortly after the debris flow damming event. The flood depth was 2.0 - 3.5 m and lasted 7 days until the dam was excavated on August 20th, 2010. This catastrophic debris-flow damming event caused 32 fatalities. More than 8,000 residents have been forced to evacuate after the debris flow occurred. To reduce the potential debris flow hazard in the future, control works have been constructed (Fig.24). Prior to this catastrophic event, debris flow hazard had been recognized in the region, but its potential for such widespread and devastating impacts was not fully appreciated.

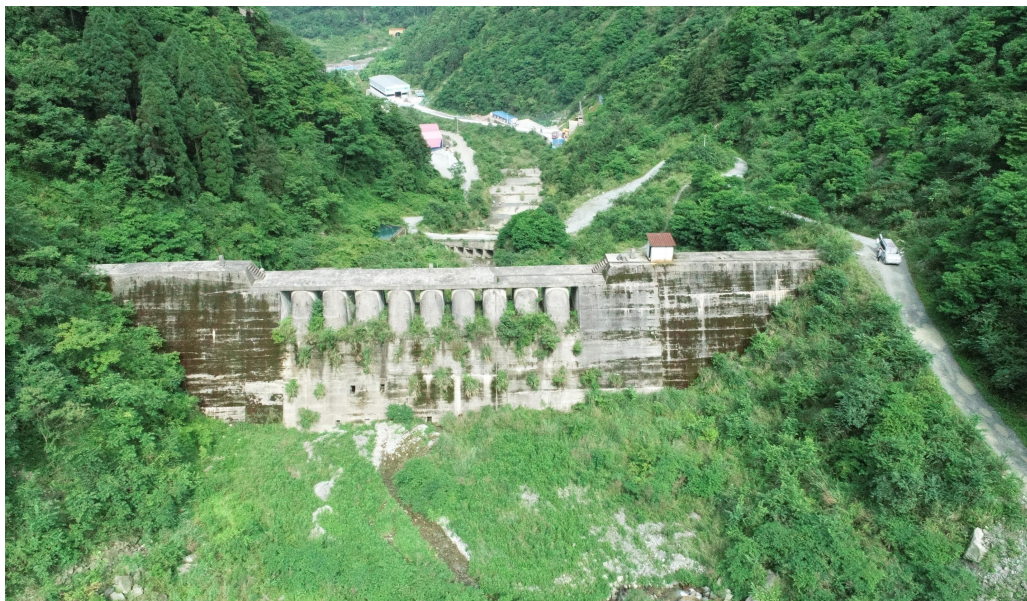
Fig. 24 Check dams constructed in the gully for debris-flow hazard mitigation
